IBM eServer BladeCenter and Cisco ESM Technology Planning / Implementation (withdrawn product)

IBM eServer BladeCenter and the Cisco Systems Intelligent Gigabit Ethernet Switch Module hints and tips

This document, TIPS0423, was created or updated on July 6, 2004.

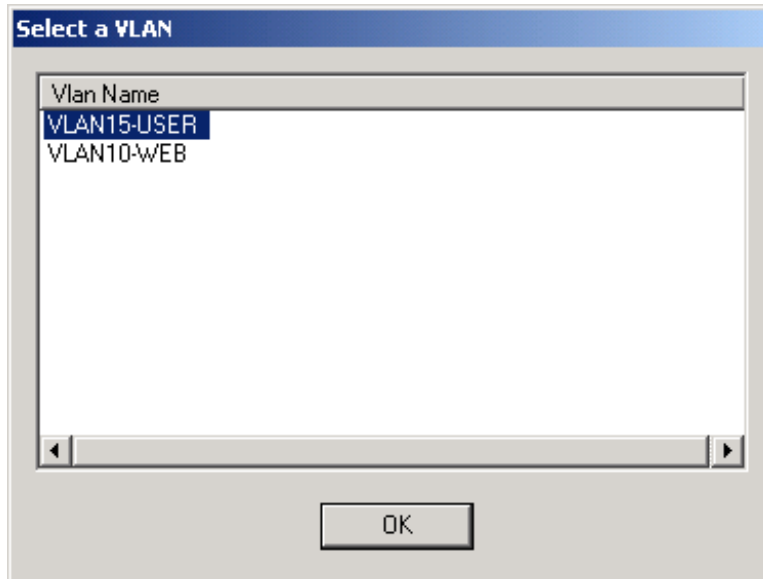
The Broadcom software, known as the Broadcom Advance Control Suite (BACS), is used to control NIC teaming on the blade servers. It has been noted that there are several selections within this software that do not permit you to cancel or otherwise back-out of a selection, and appear to force a user to perform an action they may not wish to perform.

Two such examples are when you click Remove VLAN at a Team Configuration window or select Tools->Delete a team from the menu bar. In these cases, a window similar to Figure-1 will be displayed for a user to specify a VLAN or a team to delete, and you will not be offered any obvious way to cancel the operation. To abort these seemingly un-abortable procedures, press the Esc key on the keyboard.

Note that if there is only one item in the list to delete (for example, only one VLAN or one team), the BACS software does not even give an option to select what is to be deleted, it simply deletes the one item and goes back to the original screen. If this deletion was undesired, the only solution is to click the Cancel button on the main BASC window, and exit the BASC software without saving the changes. Of course doing so will result in losing any other changes you had already made since the last time the Apply or OK button was selected.

Figure-1 BASC example of a window without an option to cancel
